Medical Devices: The Therac-25 Story

A.1 Introduction

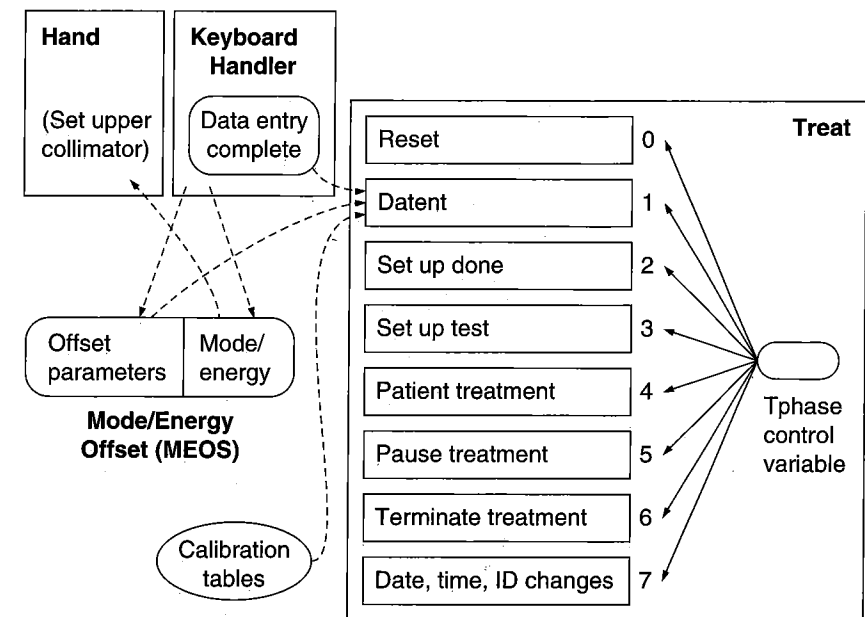
FIGURE A.3
Tasks and subroutines in the code blamed for the Tyler accidents.

But this is not the only problem. Upon exit from the Magnet subroutine, the data entry subroutine (Datent) checks the Data Entry Complete variable. If it indicates that data entry is complete, Datent sets Tphase to 3 and Datent is not entered again. If it is not set, Datent leaves Tphase unchanged, which means it will eventually be rescheduled. But the Data Entry Complete variable only indicates that the cursor has been down to the command line, not that it is still there. A potential race condition is set up. To fix this, AECL introduced another shared variable controlled by the keyboard handler task that indicates the cursor is not positioned on the command line. If this variable is set, then prescription entry is still in progress and the value of Tphase is left unchanged.

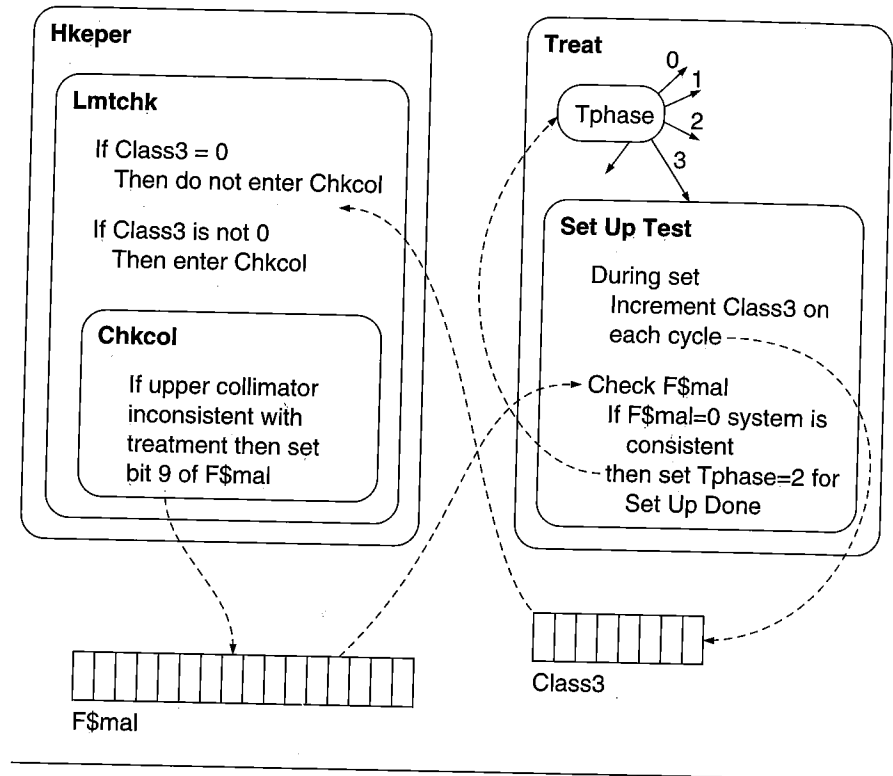
The second Yakima accident was again attributed to a type of race condition in the software—this one allowed the device to be activated in an error setting (a “failure” of a software interlock). The Tyler accidents were related to problems in the data-entry routines that allowed the code to proceed to Set Up Test before the full prescription had been entered and acted upon. The Yakima accident involved problems encountered later in the logic after the treatment monitor Treat reaches Set Up Test.

FIGURE A.4
The Yakima software flaw.
