Medical Devices: The Therac-25 Story

A.1 Introduction

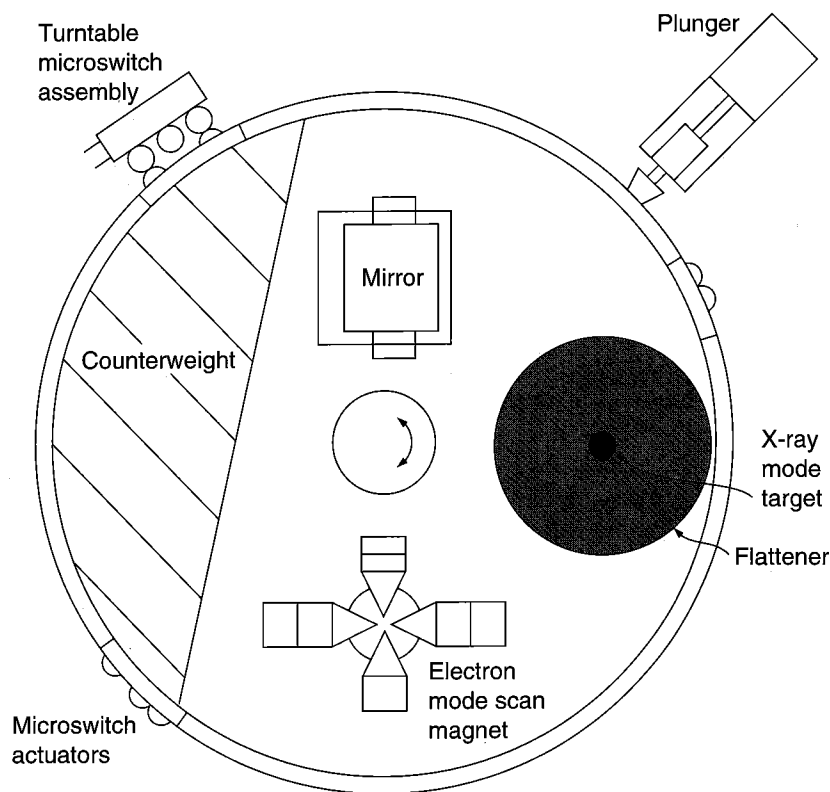
FIGURE A.1
Upper turntable assembly.

(and for checking the turntable position) so that a target, flattening filter, and X-ray ion chamber are directly in the beam path. With the target in place, electron bombardment produces X-rays. The X-ray beam is shaped by the flattening filter and measured by the X-ray ion chamber.

No accelerator beam is expected in the third or field light turntable position. A stainless steel mirror is placed in the beam path and a light simulates the beam. This lets the operator see precisely where the beam will strike the patient and make necessary adjustments before treatment starts. There is no ion chamber in place at this turntable position, since no beam is expected.

Traditionally, electromechanical interlocks have been used on these types of equipment to ensure safety—in this case, to ensure that the turntable and attached equipment are in the correct position when treatment is started. In the Therac-25, software checks were substituted for many of the traditional hardware interlocks.

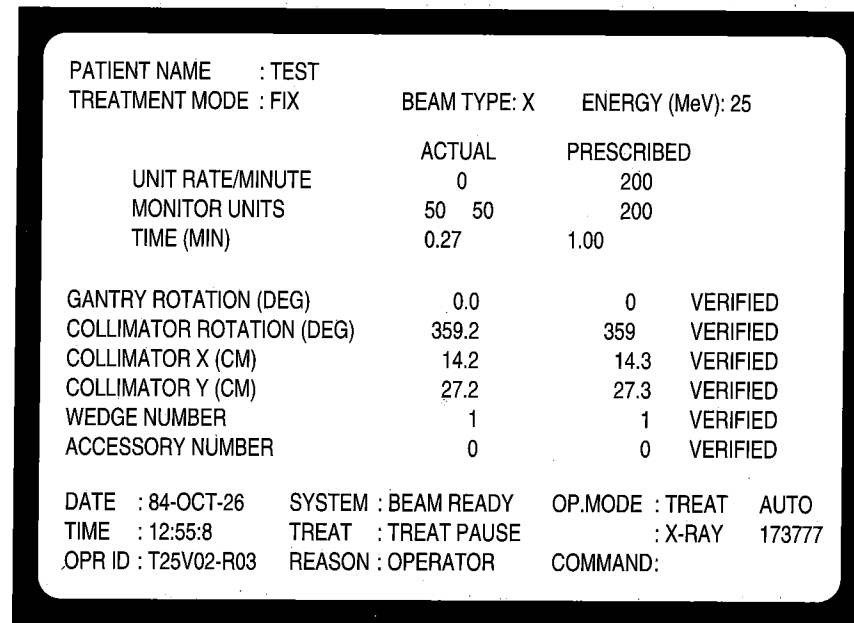
FIGURE A.2
Operator interface screen layout.

The Operator Interface. The description of the operator interface here applies to the version of the software used during the accidents. Changes made as a result of an FDA recall are described later.

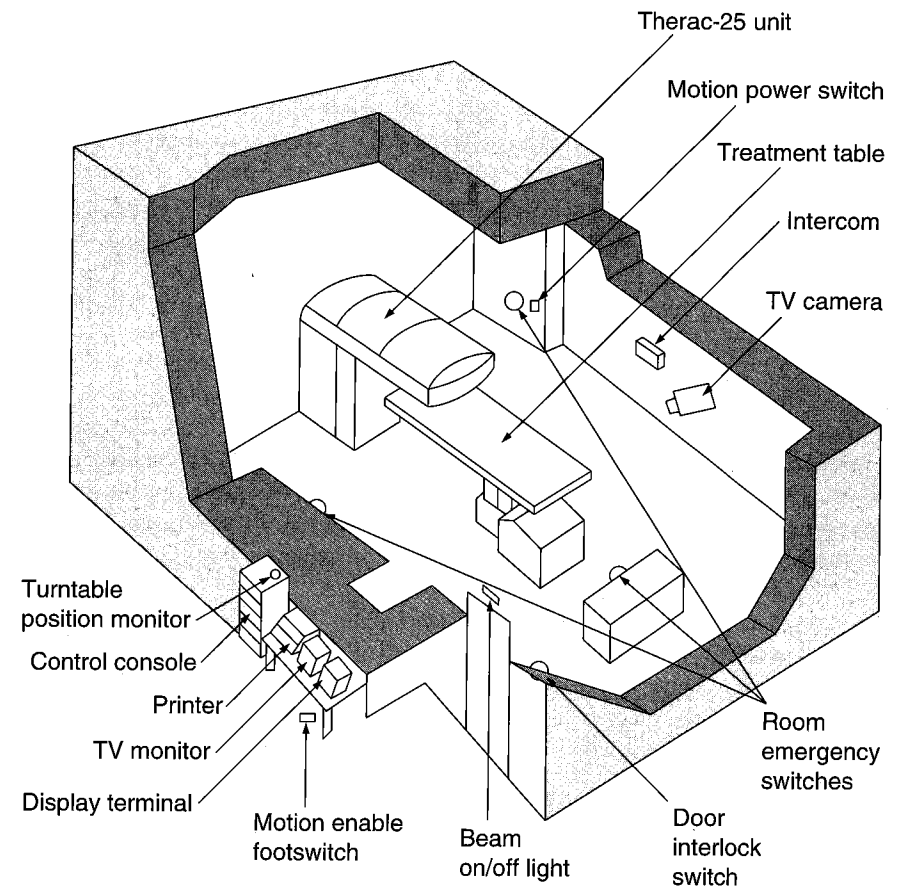
FIGURE A.5
A typical Therac-25 facility after the final CAP.
